KENNEBEC RIVER BASIN
Waterville, Maine

RESERVOIR DAM ME 00472

PHASE I INSPECTION REPORT NATIONAL DAM INSPECTION PROGRAM

SEPTEMBER 1981

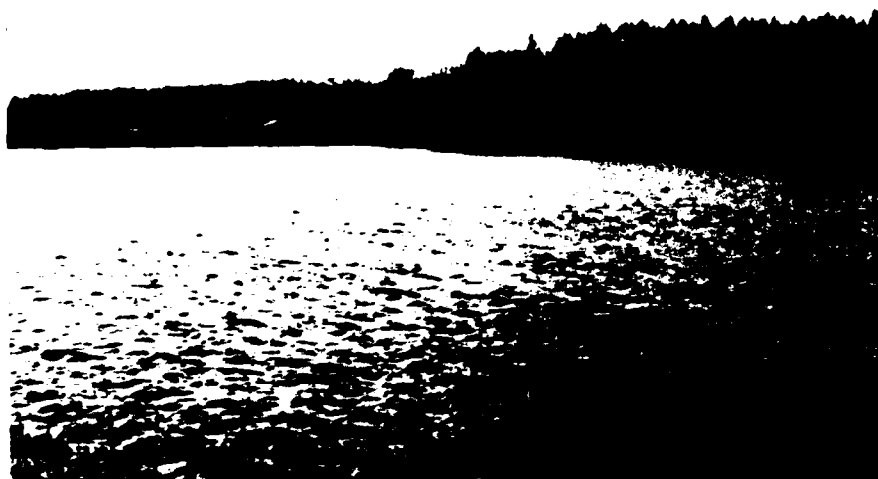
Photo 6
View Across Reservoir
from Left Side Looking
Towards Dam.
